NAVAL POSTGRADUATE SCHOOL Monterey, California

THESIS

INVESTIGATION OF A MACH 1.4 COMPRESSOR CASCADE WITH VARIABLE BACK PRESSURE USING FLOW VISUALIZATION

Michael George Hegland
March 1986

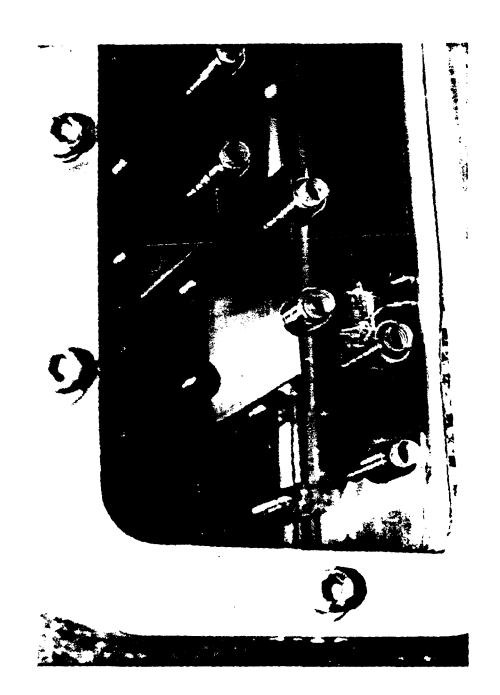
Test Section Following Failure of 1st Steel Blade Figure 17.

After six successful test runs with the steel blades installed, failure of all 4 blade retaining tabs during run seven, resulted in the loss of the number 1 blade from the test section (Fig. 17). The aft tabs appear to have failed first since a wide arced scratch was generated on the left sidewall near the trailing edge, presumably before the blade was completely free (Fig. 17a). The blade leading edge also flexed down gouging the right aft section of the lower boundary layer scoop (Fig. 17b). Several other gouges were inflicted in the sidewalls as the blade made its way out of the test section. The throttle valve and exhaust duct were free of damage.
